Cognex MVS-8000 Series

OMI 2.3.1 Release Notes

590-6413

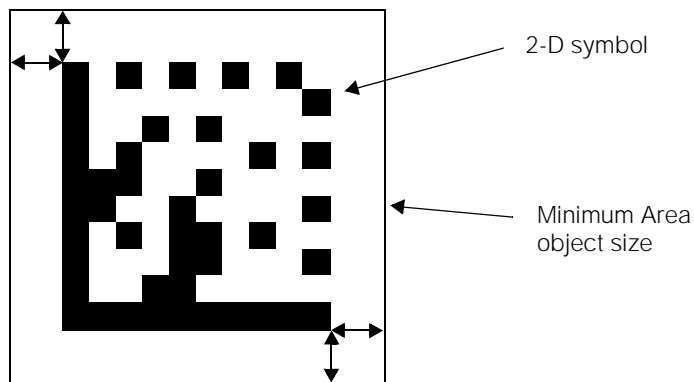
This behavior can also occur when the edge of the Area boundary is too close to the 2-D symbol in the training image. The edge of the Area boundary should be no closer to the edge of the symbol than a distance equal to twice the width of one of the individual squares that comprise the symbol, as shown in the following figure:

Typically, this behavior occurs when the 2-D symbol in the training image is warped, degraded, or at too low a resolution. If this happens when the Points are being set manually, it indicates that the parameters are close to the correct ones. If this happens when Points are being learned automatically, it indicates that either the resolution of the image is too low, or the image needs preprocessing.
